DUTCH SAFETY BOARD

MH17 Crash

Investigation into the crash of flight MH17

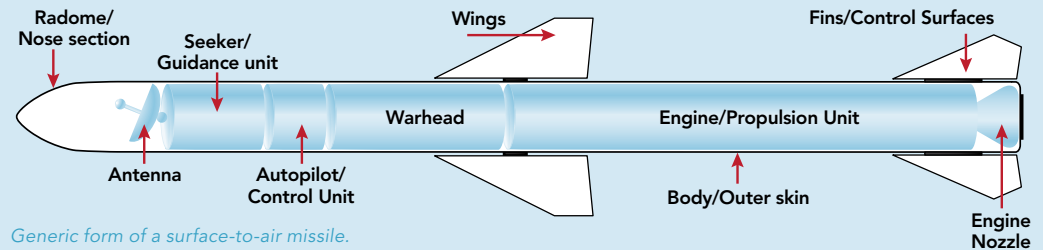
The particles found in the aeroplane and in the bodies of three of the crew members consisted of unalloyed steel. The particles are cube and bow-tie shaped. The number of impacts, the distribution pattern and the shape of the high-energy objects that were found are consistent with the pre-shaped fragments in the warhead of the 9N314M model.

Left: example of a 9N314M-warhead. Middle: The different shaped particles in the warhead. Right: 3D-print of the arrangement of the pre-formed particles.

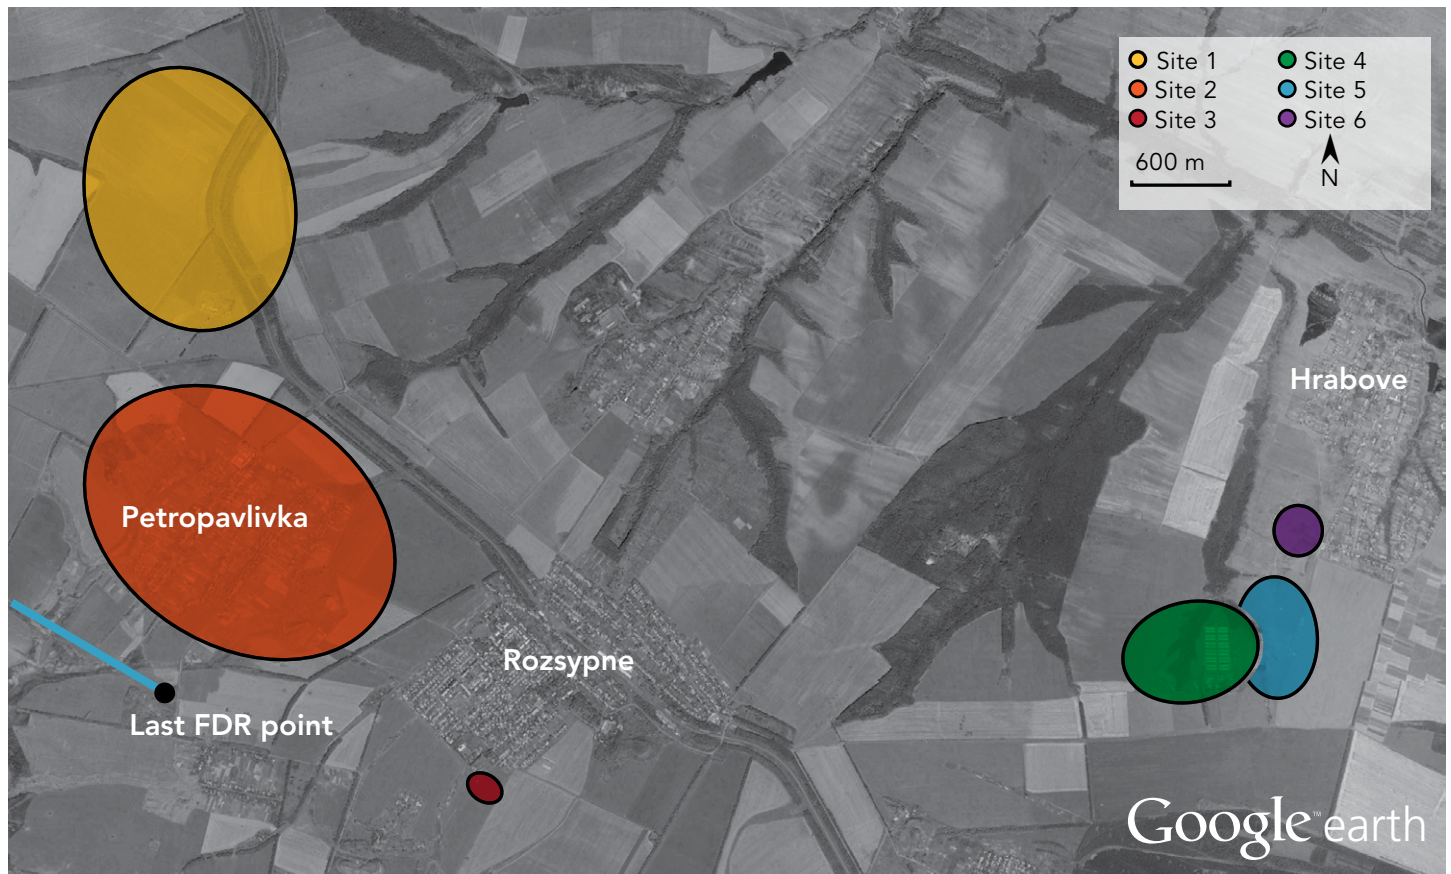
The wreckage that was found near the villages of Rozsypne and Petropavlivka (crash sites 1, 2 and 3) shows that the cockpit and the front section of the

which came to rest upside down. A fierce fire broke out at the site where the centre section and the engines hit the ground. As a result, the centre section of the aeroplane was almost completely destroyed.

The crash caused a great deal of damage in the crash area. There were no casualties among the local population.

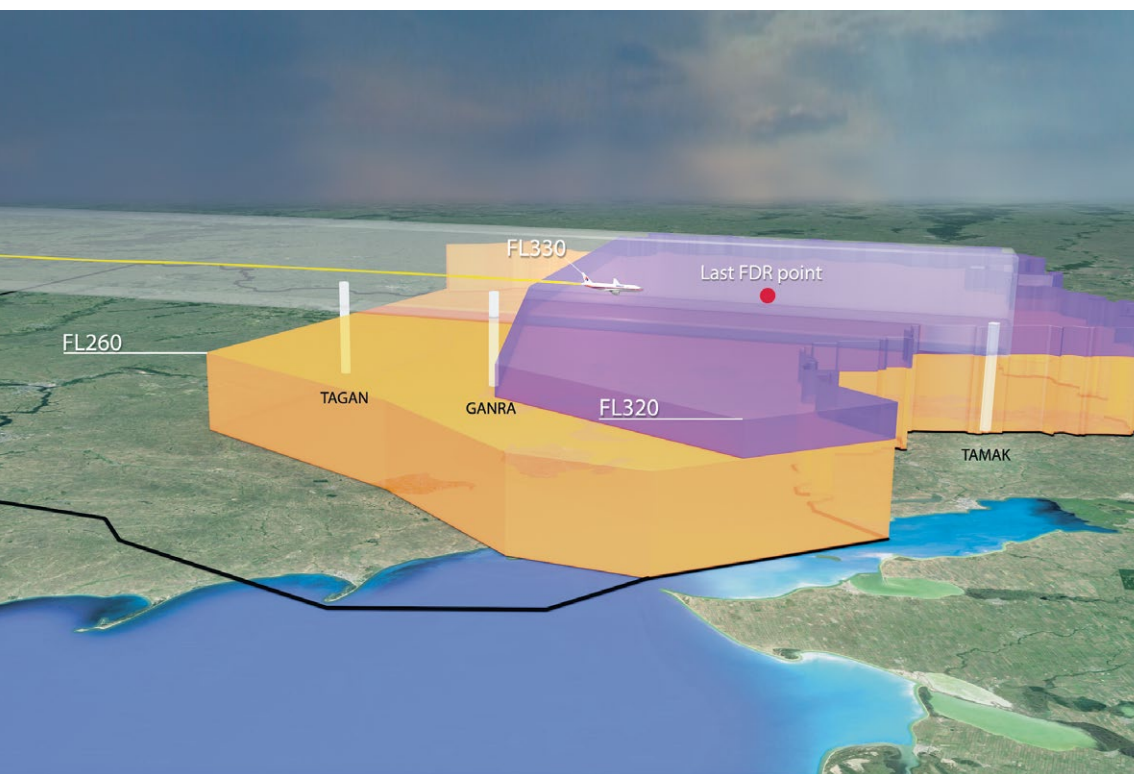
The flight route and altitude of flight MH17 and the restrictions of airspace over the eastern part of Ukraine.
